the electrical digest

Thermography Cuts Energy Costs

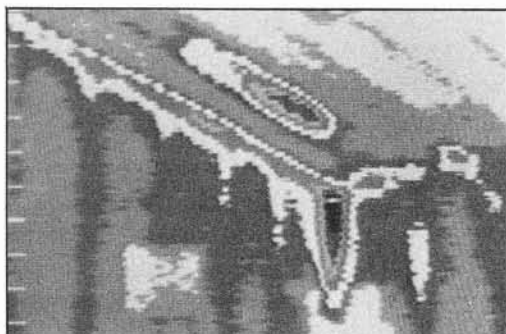
Thermogram of building interior shows cold area (black corner) where a squirrel had built a nest in a cathedral ceiling.

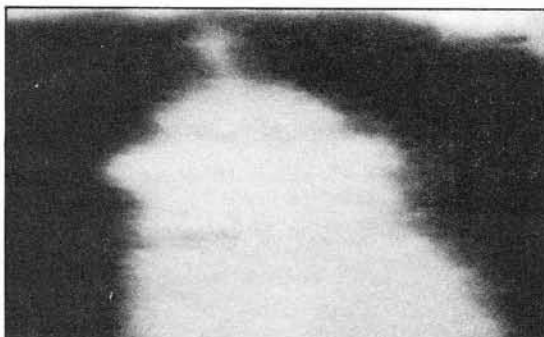
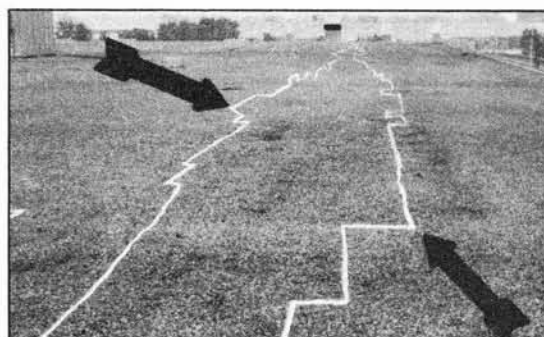
Thermogram of suspect moisture damage with corresponding photograph showing the spray-painted outline of the same area.

Infrared thermography provides valuable information used to target the maintenance of standard built-up roofs. Moisture-damaged roof insulation generates a thermal anomaly which can be detected with an infrared scanner. Such a thermal anomaly can result from either one of two factors: as stored solar energy in wet insulation, or increased heat flow from the building below through the damaged insulation.

By using an infrared roof moisture survey, management can visualize the extent of roof damage and formulate economic solutions. Roof problems which were once thought to require total roof replacement often may be solved by effectively targeting roof repairs. With thermography, roofing systems can be better managed with reduced annual maintenance costs.

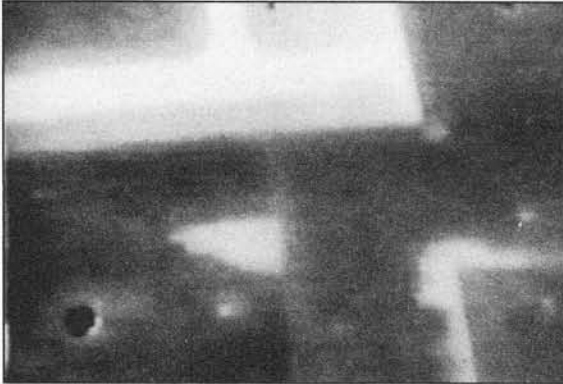
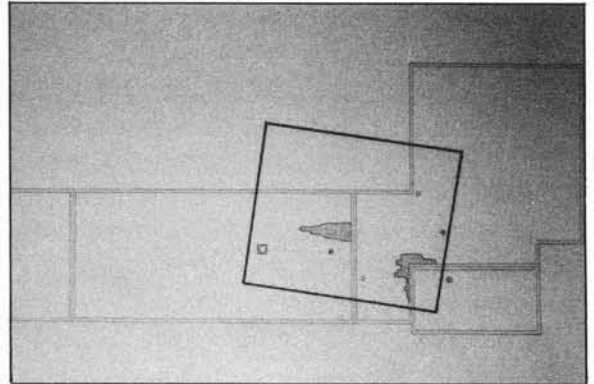
Aerial thermography roof moisture survey findings – thermogram with corresponding view of roof sketch marked with approximate size and location of suspect areas.

Qualitative aerial overviews can be acquired by basing the thermographer and equipment in a helicopter. This approach is used by owners of larger volumes of roofing systems to establish priorities of roof-level quantitative surveys, or to better estimate roof maintenance budget requirements.

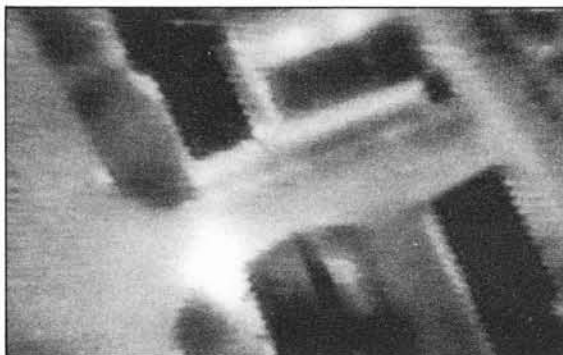
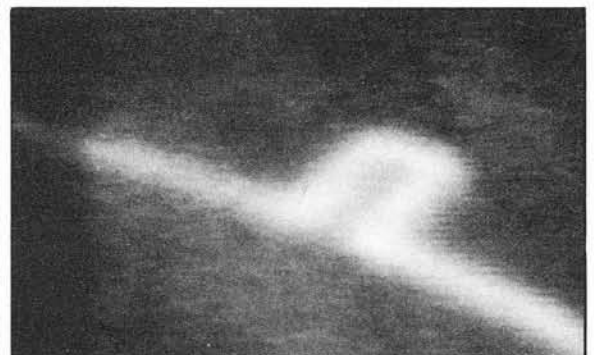
Aerial thermography also can provide an accurate overview of underground steam distribution systems. Thermal anomalies indicative of steam or condensate leaks and damaged piping insulation can be detected in direct-buried systems.

Sample thermograms from an aerial thermography steam distribution system inspection showing a steam leak beneath a street (left). Right thermogram shows the normal thermal expression of an expansion loop.

Targeting steam line maintenance with an infrared thermographic survey helps save steam energy dollars while avoiding excavation of the entire system to locate steam problems.
